MEMORANDUM

DATE: June 29, 2023

RE: FY23/FY24 MVP Action Grant – Towns of Chester, Middlefield, and Blandford
Beaver Assessment Technical Memorandum—Town of Chester

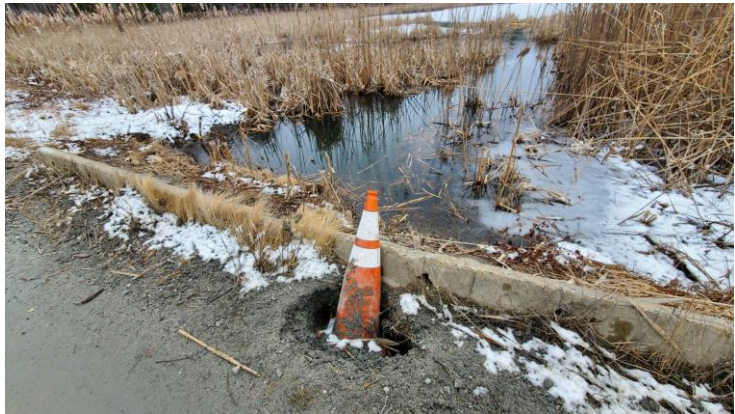
The impoundment on Lyman Road is located at a low-lying dirt section of the road approximately half-way between Skyline Trail and Mica Mill Road. At the roadway, the impoundment is very close to the road surface in both the horizontal and vertical planes (Figure 5), and the culvert passing under Lyman Road is submerged due to the backwater from the impoundment. As seen in the image at right, a sinkhole had formed at the existing road-stream crossing at the time of our field assessment in February 2023.

Figure 5. Looking downstream toward the impoundment at Lyman Road, February 22, 2023. Note the sinkhole at the existing road-stream crossing.

- Replace and right-size the existing crossing to convey existing peak flows and those expected as a result of climate change projections for increased storm intensity and peak flows; this will simultaneously help to discourage blockages of the culvert (both active damming by beavers and passive blockages from sediment and debris accumulation).
- Following replacement, continue to maintain and monitor the existing (newly installed) flow-control device and assess beaver response.

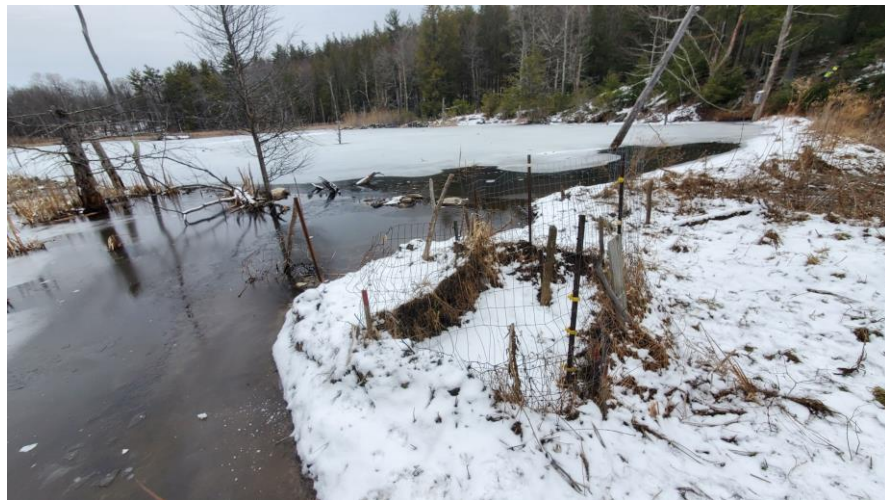
Figure 6. View of the impoundment, looking north. At the foreground, fencing protects the flow leveling pipes installed by the property owner. February, 2023.

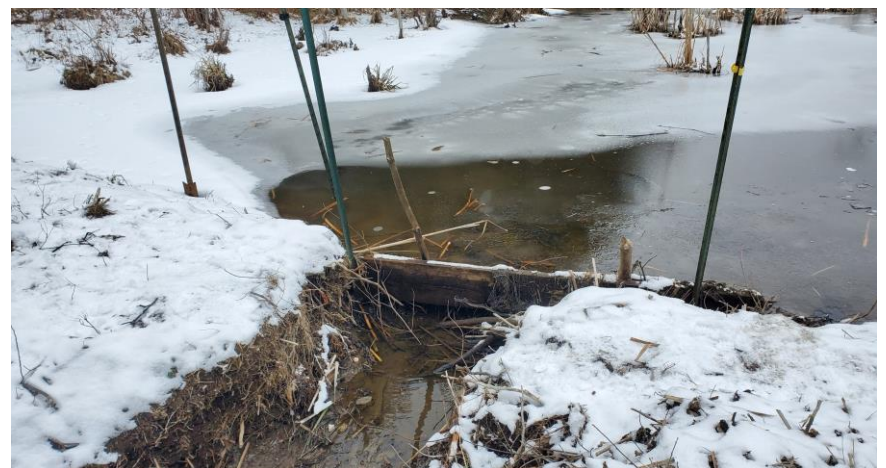
Figure 7. Spillway/stop logs installed at the south end of the impoundment by the landowner to help maintain water levels below the elevation of Lyman Road to prevent overtopping. February, 2023.

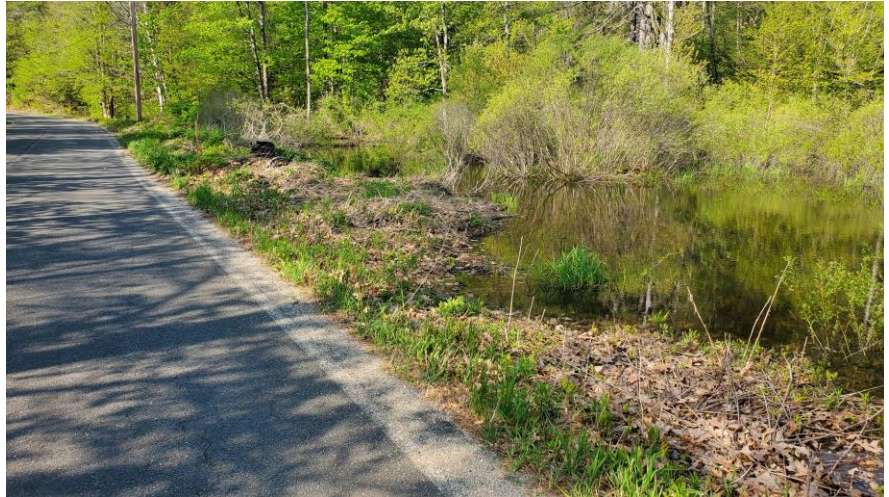
Figure 9. View of the impoundment and proximity to E. River Road, looking south. May, 2023.

Current and Potential Impacts (medium-low): Despite the proximity to the roadway, potential impacts from beaver activity at this location are limited by the existing site topography. A resident we spoke with did indicate that the roadway periodically floods. However, given that the grade drops off substantially on the opposite side of the road, and continues to drop down to the elevation of the riverbed just to the east, there is little opportunity for ponded water to be confined in the landscape if the impoundment reaches the elevation of the road. We anticipate that overtopping events at this location would certainly result in a wet or potentially icy roadway, but we would not expect to see ponding to any depth that would be problematic. Further, there was no evidence on the east side of the road of any confining areas or evidence of ponding. The property across the street at 495 E. River Road likewise does not

- The original failed culvert and beaver deceiver could be replaced and right-sized to maintain stream flow under the road; however this would likely not be a cost-effective solution given the limited benefits or risk reduction for infrastructure and property.
- Restoration of the excavated overflow/diversion channel is recommended to stabilize the exposed soils and prevent turbidity and sedimentation of the downgradient stream channel and river. Creating a broad, vegetated flow path through this area may help to achieve the same goal of providing an overflow outlet for the impoundment without having detrimental effects to the downstream waterways.
- Better understanding the sources of concern around overtopping may suggest other means of improving the roadway drainage to improve resilience and road safety while coexisting with the beaver impoundment.

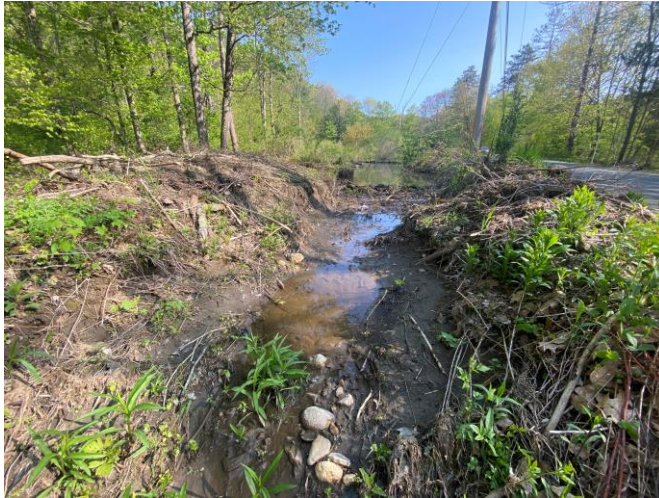
appear to be situated such that it would be impacted by overtopping of the road. An abandoned outfall or stream channel immediately south of the house on this property would direct water down toward the river and away from the home.

Figure 10. View of the overflow/diversion channel that has been dug to direct water from the impoundment south along E. River Road to an existing stream. May, 2023.

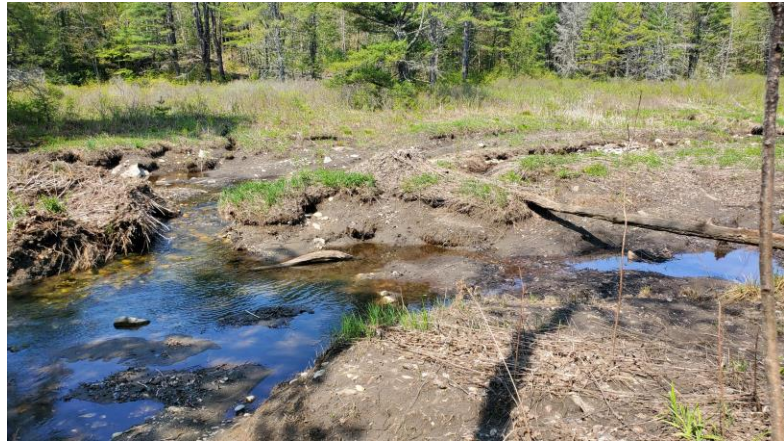
Figure 12. View of the former area of impoundment along Kinne Brook as observed in May 2023. Areas of bare soil indicate the extent of the impoundment prior to dam breach.

west, away from the roadway and higher up in the landscape on tributary streams. In May, our field crew passed this site a second time and observed that the primary dam had been breached. It was unclear whether this was a natural occurrence or if the dam had been breached with machinery. The upper dams and impoundments remained intact. When intact, the primary beaver impoundment at Kinnebrook Road was estimated to be 3.6 acres, with an approximately 2.57 square mile total contributing drainage area.

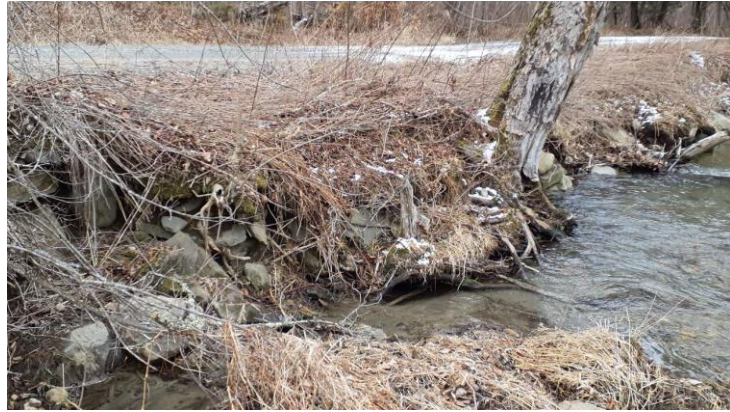
Figure 13. View of the intact impoundment with approximately four feet of freeboard between the impoundment and roadway. February 2023.

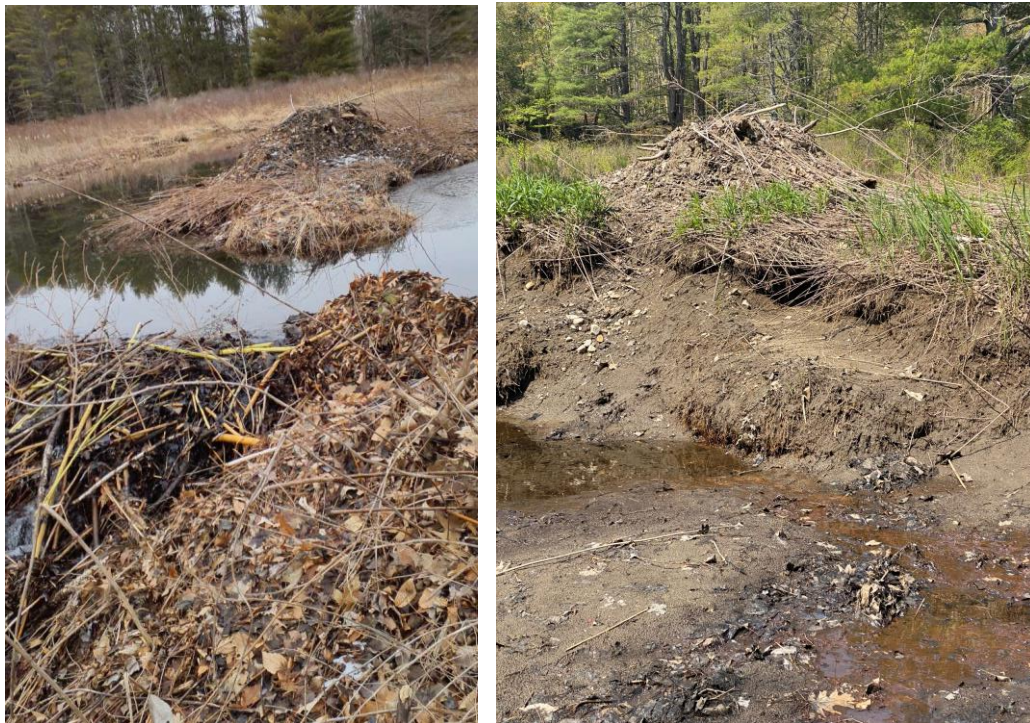
Figure 14. Left: The intact beaver dam is visible at the fore of the image, with the main beaver lodge in the rear, surrounded by the active impoundment. February, 2023. Right: The same lodge is seen following the breach of the dam and draining of the impoundment. May, 2023.

- Prevent trapping and other control strategies (e.g., breaching of dams)
- Support beaver populations at the site (i.e., plantings, BDAs), to enhance resiliency and encourage sustained beaver activity at the site.

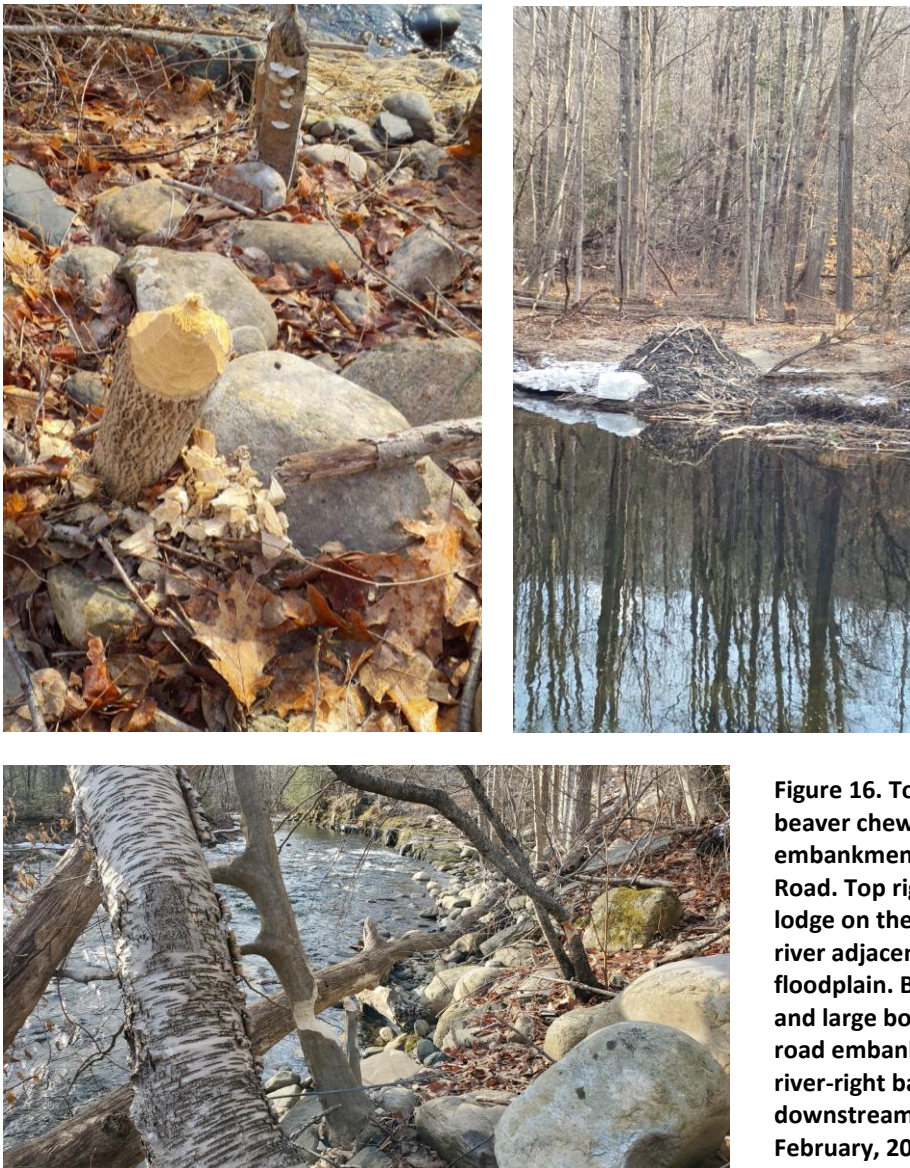
Figure 16. Top left: Fresh beaver chew on the embankment of Middlefield Road. Top right: Active beaver lodge on the east side of the river adjacent to the floodplain. Bottom: Bedrock and large boulders along the road embankment on the river-right bank looking downstream. All photos: February, 2023.

Located across from 166 Middlefield Road, this area is just upstream of an island in the river. Fresh beaver chew was observed on the road side of the river, and a lodge was observed on the opposite side of the river in the low floodplain area between the river and the rail embankment. On a smaller waterbody with lower flow, this would be a likely location for a beaver dam across one or both branches of the river. However, damming would be unlikely on a river the size of the West Branch of the Westfield, and should a dam be successfully built during a period of low flow, we would not anticipate that it would remain intact under normal river conditions.

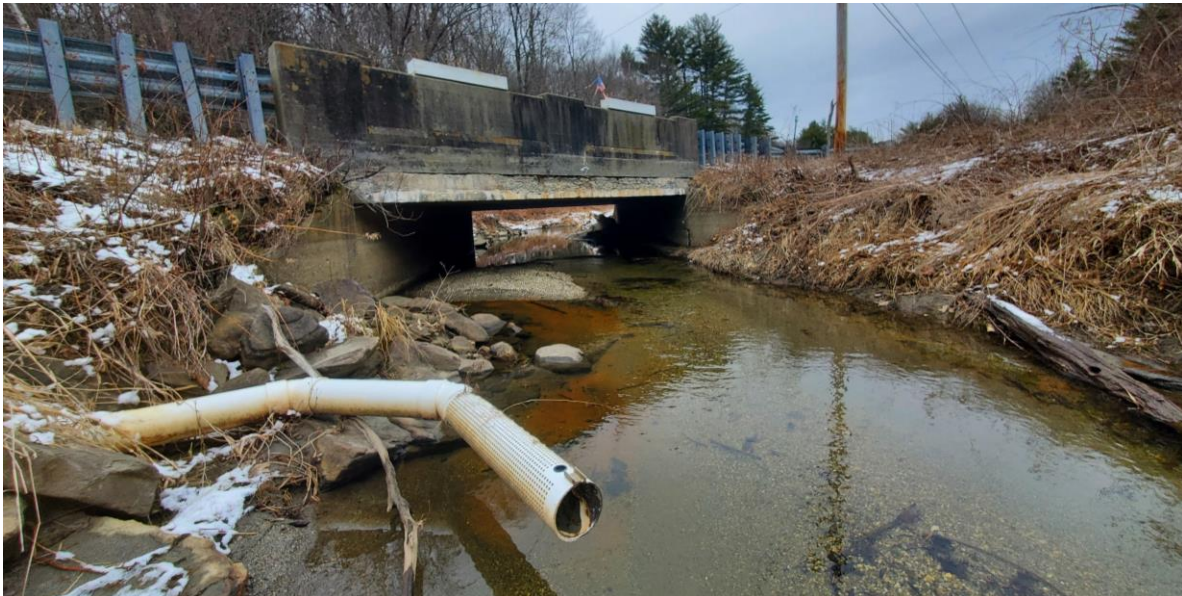
used to reach into the beaver impoundment is no longer viable as its position is approximately 18-24” above the water level of the free-flowing brook.

Figure 18. The exposed dry hydrant at the crossing of Skyline Trail and Roaring Brook no longer offers fire protection as it does not reach the water. February 2023.

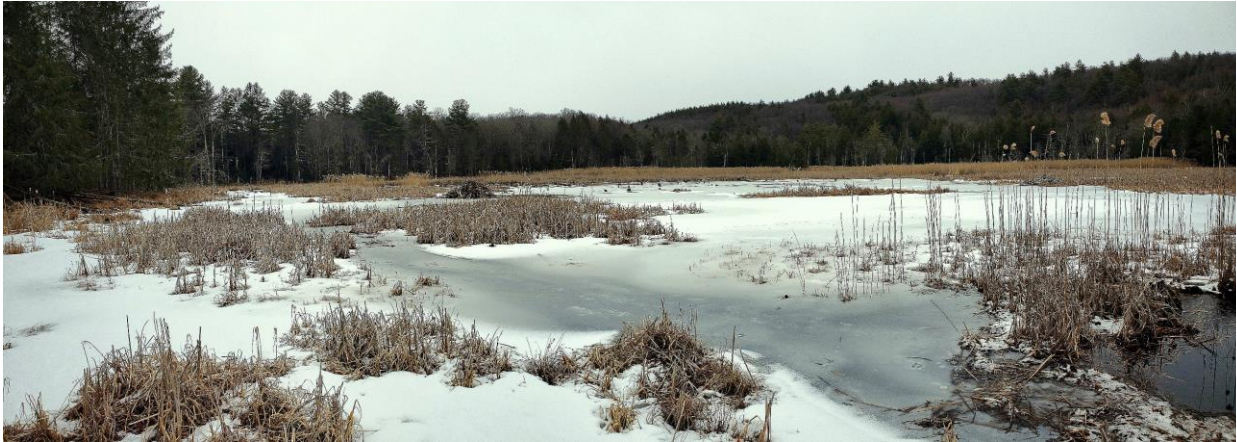
Figure 19. Expansive beaver wetlands east of Fisk Road. February 2023.

An extensive beaver wetland was identified in aerial imagery and visited in the field along Fisk Road within the Hiram H Fox Wildlife Management Area. A formal assessment was not conducted at this site as observation revealed that the impounded area is both substantially set back from the roadway and downgradient of the road within an extensive area of undeveloped, protected lands. Any potential flood impacts would occur where Skunk Brook crosses an abandoned portion of the historic Fisk Road. This area serves as a de facto beaver restoration zone, with the active population maintaining healthy wetland ecosystems within protected lands.
