# Chester Water Asset Management Plan

Town of Chester, MA

August 2025

**Tighe&Bond**

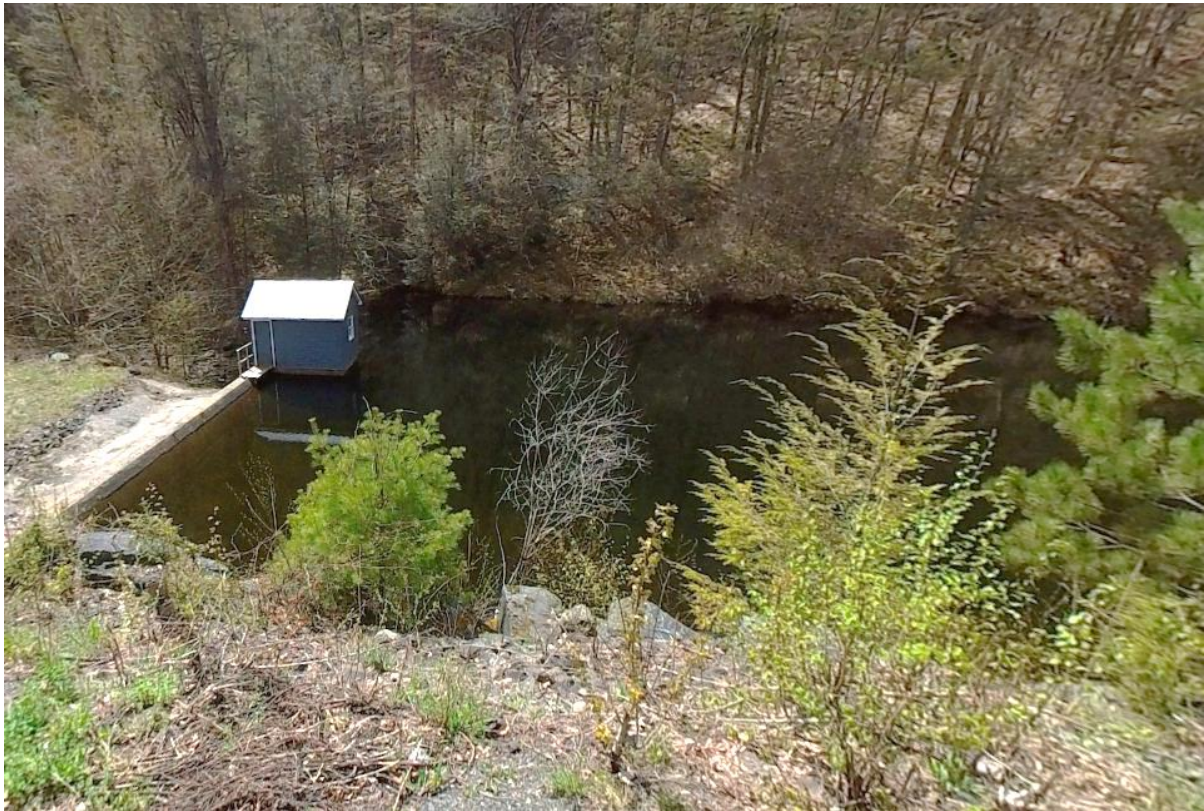
**FIGURE 2-2**  
Austin Brook Reservoir

The Austin Brook Reservoir is located ½-mile off US Route 20 in Chester, on Reservoir Road. The reservoir has a surface area of approximately 0.3 acres and a drainage area of 1.25 square miles with a safe yield of 115,000 gallons per day. The reservoir is equipped with a gate house, screened intake, and concrete dam. Historically the reservoir has elevated turbidity during extreme weather events, this has made the reservoir unreliable. To reduce the influent turbidity caused by weather events it is necessary for the Town to periodically drain and clean the impoundment of sediment. Austin Brook’s raw water pumps are only a few years old and are exercised frequently.

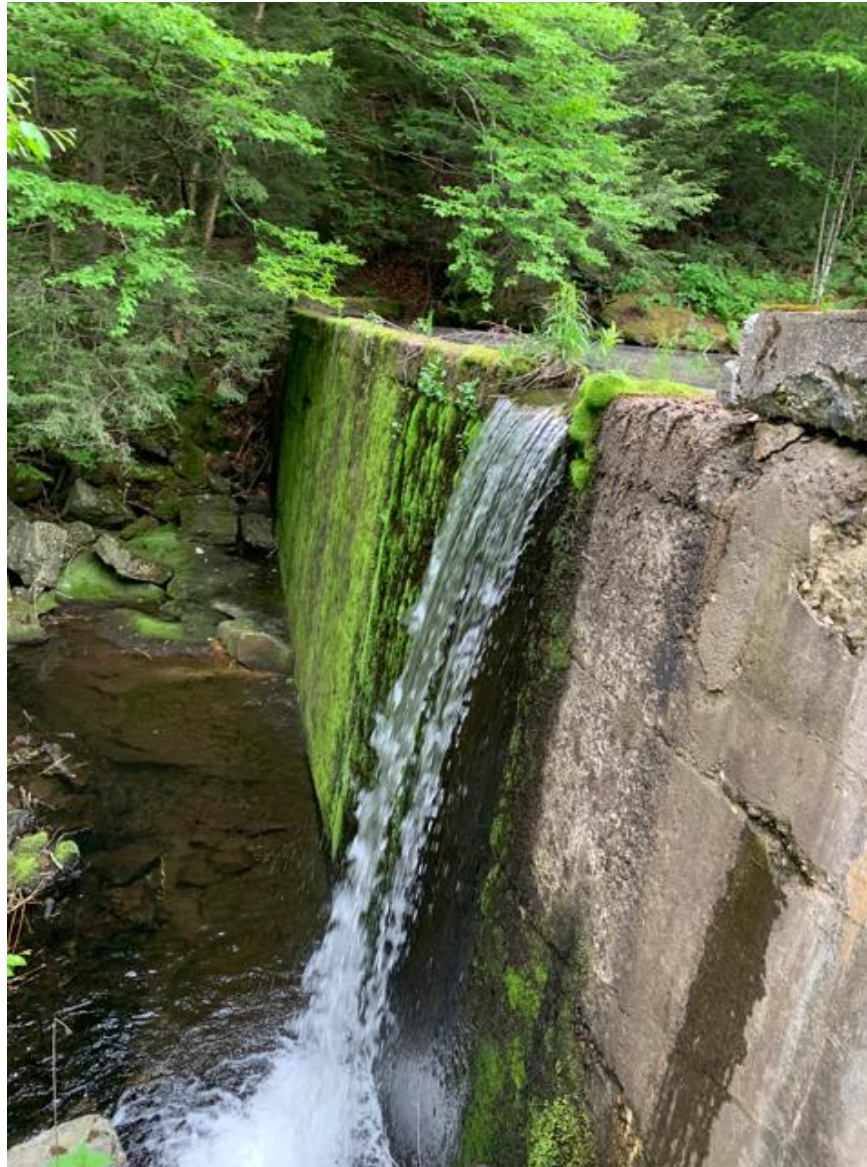
**FIGURE 2-3**  
Austin Brook Dam

The Austin Brook Dam can be seen in Figure 2-3. The dam is made of concrete and is equipped with a bypass line and spill way. According to Town records, the dam needs some repairs as per a 2017 Lenart Consulting Services inspection report. The report was unavailable upon request. It is recommended that the Town conducts an updated dam inspection to assess current condition and to verify if there is a need for repairs beyond what was included in the 2017 inspection recommendations.

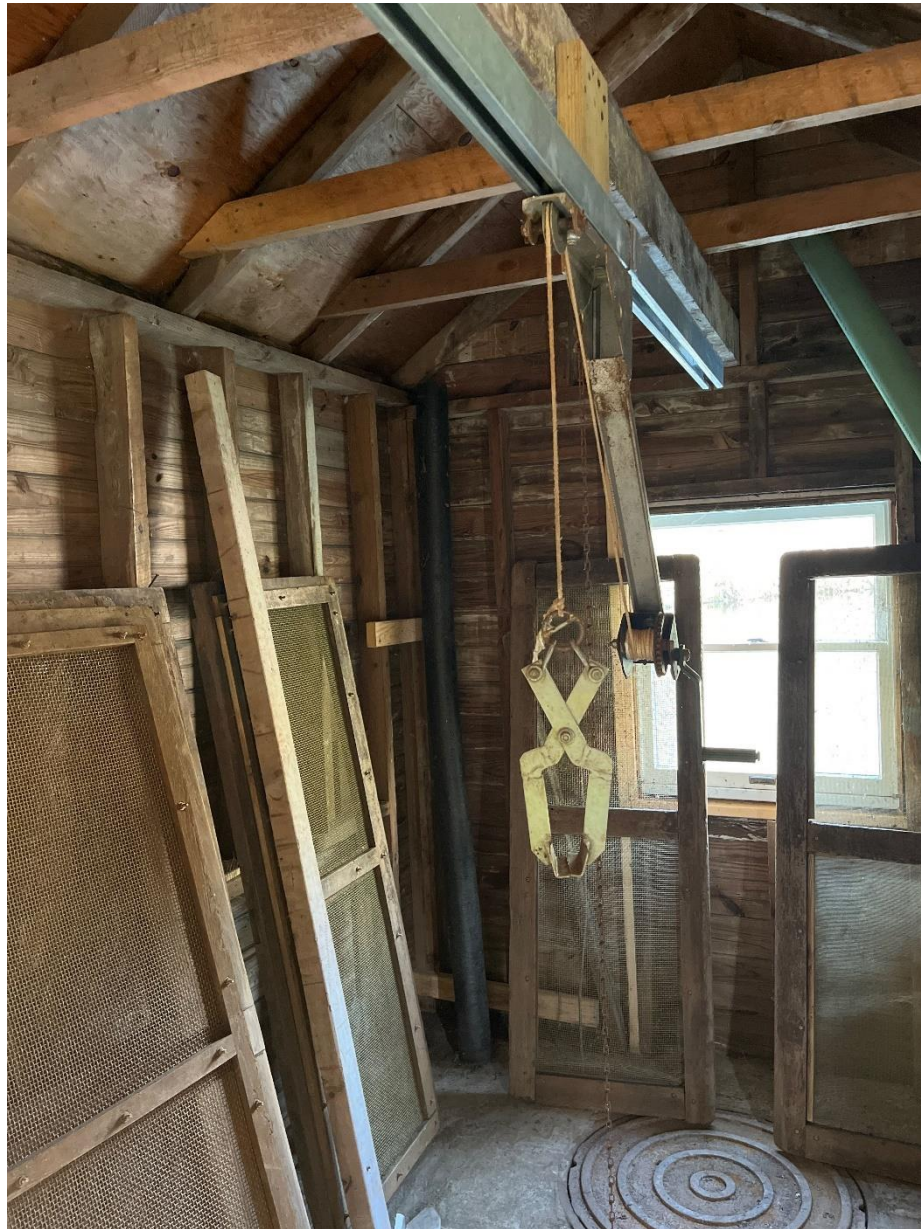
**FIGURE 2-4**  
Austin Brook Gate House

The Austin Brook Gate House can be seen below in Figure 2-4. Other than the water gate structures, the gatehouse contains raw water screens as well as a screen hoist (shown below). The building should be provided with properly designed ADA access, and railings are also recommended to improve overall safety at the access points and the raised valve platform.

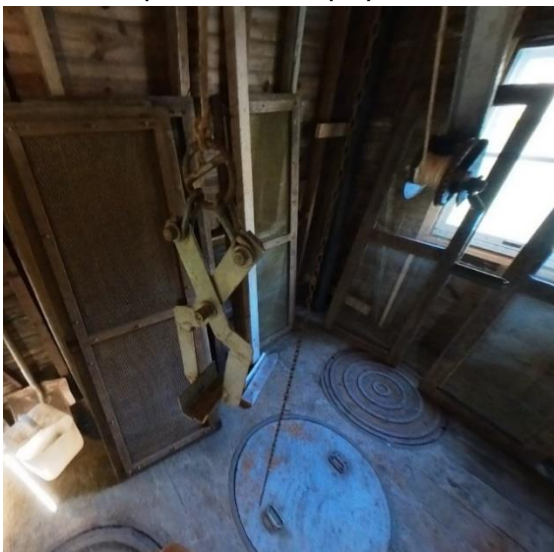
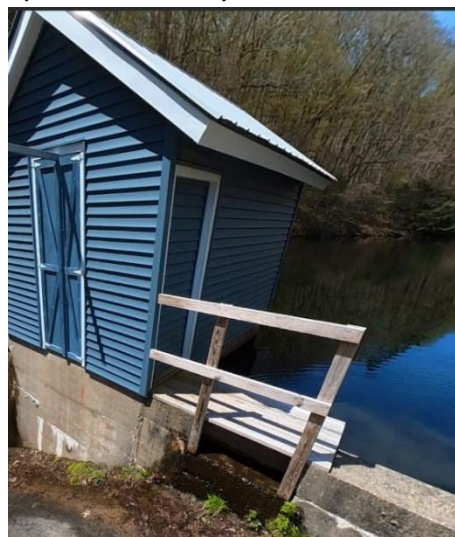
The Austin Brook Reservoir is located at the end of Reservoir Drive, adjacent to the Chester water treatment facility. Until recently, Austin Brook Reservoir had been the primary source of water for the Town. Issues with iron and manganese have caused concerns with the use of the reservoir. Historically, sedimentation in the reservoir has been an ongoing concern and requires regular maintenance. Sediment removal maintenance was performed in 2024 and needs to be performed on a more frequent/consistent basis. The existing screens for the screen house were intended to remove larger debris; however, finer debris and sediment has passed through these screens and creates issues with the filter media. Our recommendations for the screens would be to replace the existing screens with ones capable of filtering finer debris while minimizing operation and maintenance by staff. The gate house is equipped with a hoist system with no load rating and appears to be undersized for handling any heavy equipment. It is recommended that the screens and hoist system be upgraded. Additionally, as part of the screen house upgrades it is recommended that the access path to the screen house be upgraded with an aluminum or galvanized steel access walkway and stairs with railings and toe plates. Additionally, the existing dam is showing signs of structural damage, it is recommended that a full evaluation of the dam be conducted to determine the scope of improvements. As part of the dam improvements, it is recommended that the Town put aside funds for rehabilitation. Lastly, we identified that feeding a pre-oxidant, as originally recommended by Dr. Gullick, could potentially aid in reducing total organic carbon to the system which would help reduce disinfection by-products that the Town struggles with. We recommend that a study be conducted to determine if a pre-oxidant would be beneficial and that funds be put aside to pay for the installation of a pre-oxidant system if beneficial.

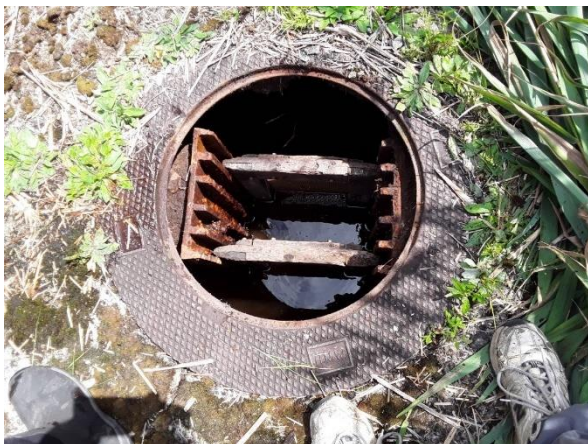
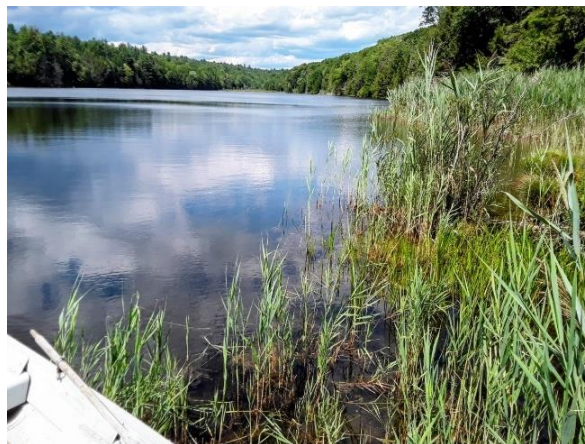
Horn Pond is the secondary water source for the Town of Chester and flows by gravity to the water treatment facility. Horn Pond is located entirely in the Town of Becket and is currently only available by boat via private property. The existing access road to the site is no longer accessible due to storm damage. Horn Pond’s PVC intake pipe was recently anchored to the bottom of the pond by the Town’s Water Commission. Historically this intake line has been prone to air binding which is referenced in previous engineering reports. The intake pipe sends water through two screens before traveling several miles to the treatment plant. It is recommended that a full inspection of the intake line be conducted to evaluate its condition. It is recommended that the Town set aside funds to repair/replace the inlet line and inlet manifold as needed in order to maintain Horn Pond as an operational source. Recent site visits and investigations by the Town have shown that there has been an increase in the growth of aquatic vegetation within the pond, which has reduced accessibility to the pond and could be impacting overall raw water quality. Due to limited landownership rights, frontage, and lack of passable access road, only limited maintenance activities on screens and valves can be conducted by Town staff. It is recommended that the Town rebuild and improve the access road or establish a more permanent right-of-way entry to the pond. The intake is in the middle of the pond and requires a boat and diver to access, making it difficult for operators to perform maintenance. The existing screens and gate valves for the intake are also in a location that requires boat access. The existing screens appear to be undersized and lack regular maintenance due to this limited access. It is recommended that a new screen system be installed. We identified that feeding a pre-oxidant could potentially aid in reducing total organic carbon to the system which would help reduce disinfection by products that the Town struggles with. We recommend that a study be conducted to determine if a pre-oxidant would be beneficial and set funds aside to implement the findings of this study.

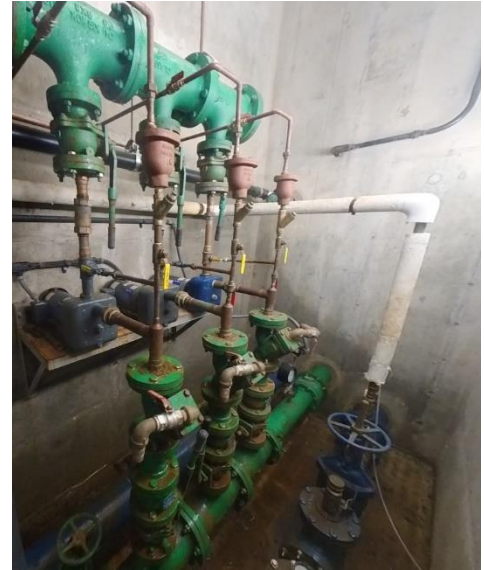
The raw water enters the water treatment plant through the plant’s basement. When Horn Pond is utilized as a raw water source, water flows directly from the pond to the top of the filters. When Austin Brook is used, the raw water must be pumped up, using self-priming pumps, through a 1” water line to the 6” pump headers to allow water to be lifted to the filter beds. Currently the raw water pumping system has several issues, the existing 6” raw water check valve has been identified as a potential failure point for the system and it is recommended that this check valve be replaced in-kind. The existing raw water pumps appear to be different from the originally specified pumps and as such are inadequate at moving water on top of the filters. It is recommended that an engineering study be conducted to identify a new pumping solution. As part of the pumping evaluation, it is recommended that the Town put aside funds to upgrade the existing pumping system.

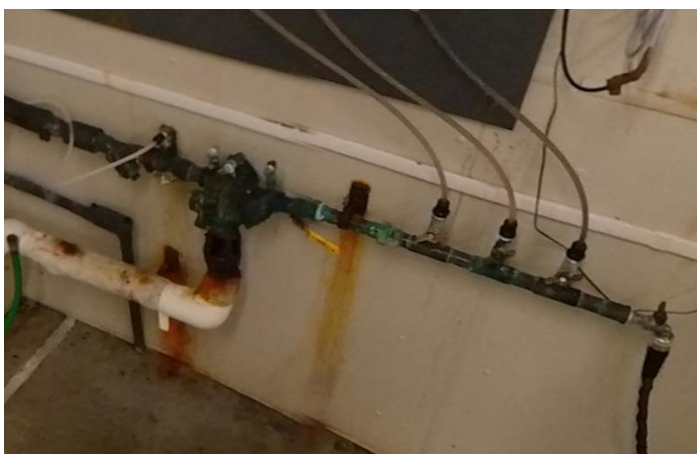
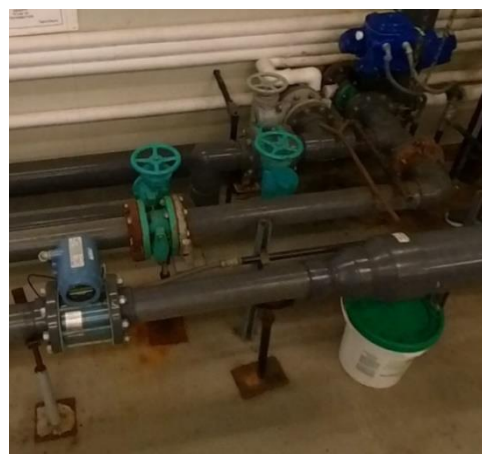
The main floor of the treatment plant contains most of the plant’s piping, valves, inline data collection hardware, laboratory equipment, and chemical feed equipment. During our site visit several assets were found to be corroded and in need of rehabilitation. The existing pipe supports, and pipe valves need rehabilitation. It is recommended that the pipe supports be replaced in kind and that the valves be surface prepared and repainted to protect them from additional corrosion. Additionally, it was found that the existing backflow preventer for chemical addition needs replacement and should be replaced in-kind. Lastly, in addition to the pre-oxidant studies that are proposed for the two raw water sources, it is recommended that an additional study be conducted to evaluate the growth of disinfection-by-products in the finished water while utilizing different source waters.

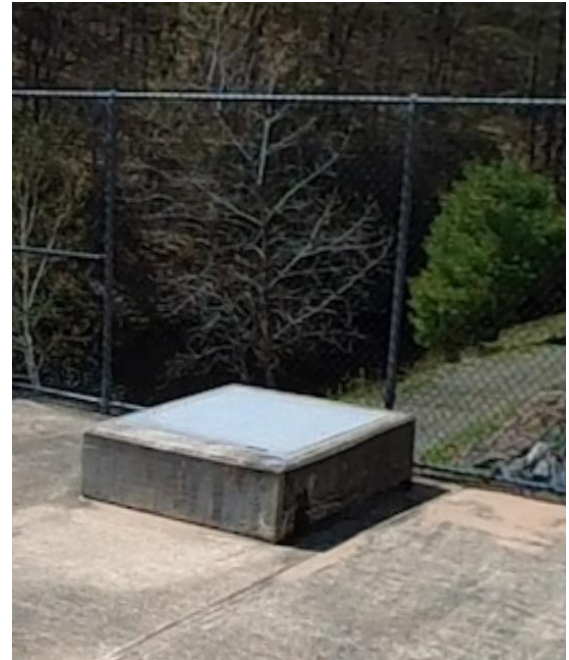
The water treatment plant has three filters that are located on the roof of the treatment plant and provide most of the treatment for the Town’s drinking water. The clearwell is the Town’s water storage facility below the filters. The Town recently removed and replaced the filter media in all three filters. During our site visit, structural concerns were identified for the filter and clearwell exterior walls and the six filter hatches. It is recommended that these structural concerns be addressed to ensure that the assets do not fail. Lastly, it is recommended that the filter roof be provided with additional site lights to provide additional security to the site and for maintenance purposes during the night hours.

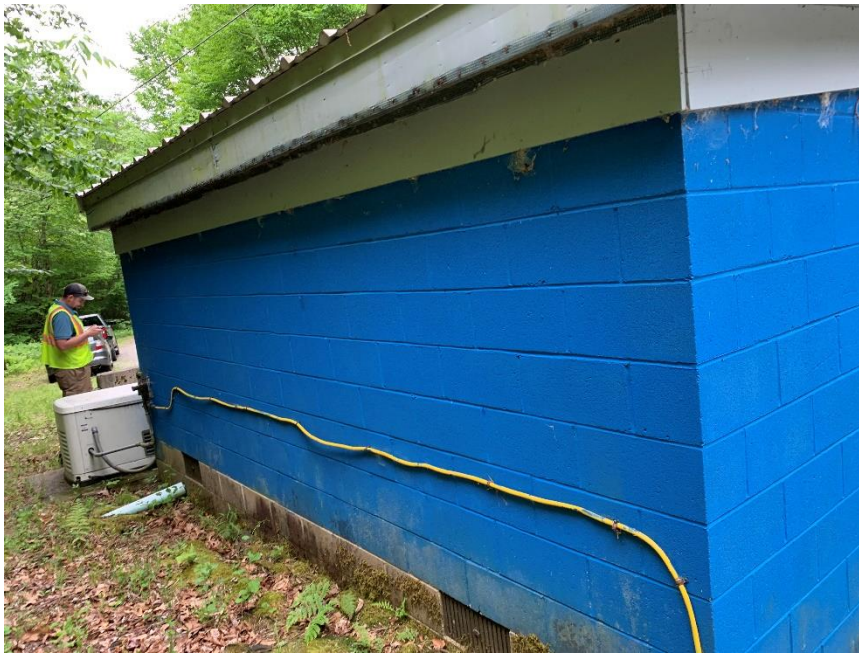
The Former Chlorination building is located near the bottom of the access drive to the water treatment plant. During our site visit we identified that the building has several breaches in it that have allowed small animals and insects to enter the building. It is recommended that holes around the building be sealed, and the ventilation pipes be screened to avoid potential contamination.
