LH TURN ON Hydrant Inspection Report	
Hydrant Number #1	4-18-23
Location	RRH #1
Pressures	Nozzle 2 1/2"
	Initial STATIC 88
	Residual 25
	Pitot 22
Flow gpm	740
Time Flushed Min	15 MIN.
Water used gal	11,100
Paint	NEEDS PAINTING
Chains	GOOD
Caps	GOOD
Stems	GOOD
Packing	GOOD
O-Ring	GOOD
Top Nut	GOOD
Valve	GOOD
Valve Seat	GOOD
Condition of Water	CLEAR WHEN FINISHED FLUSHING
Remarks.	Isolation valve pipe needs to be dug up because it was hit and has to be recentered.

Hydrant Inspection Report

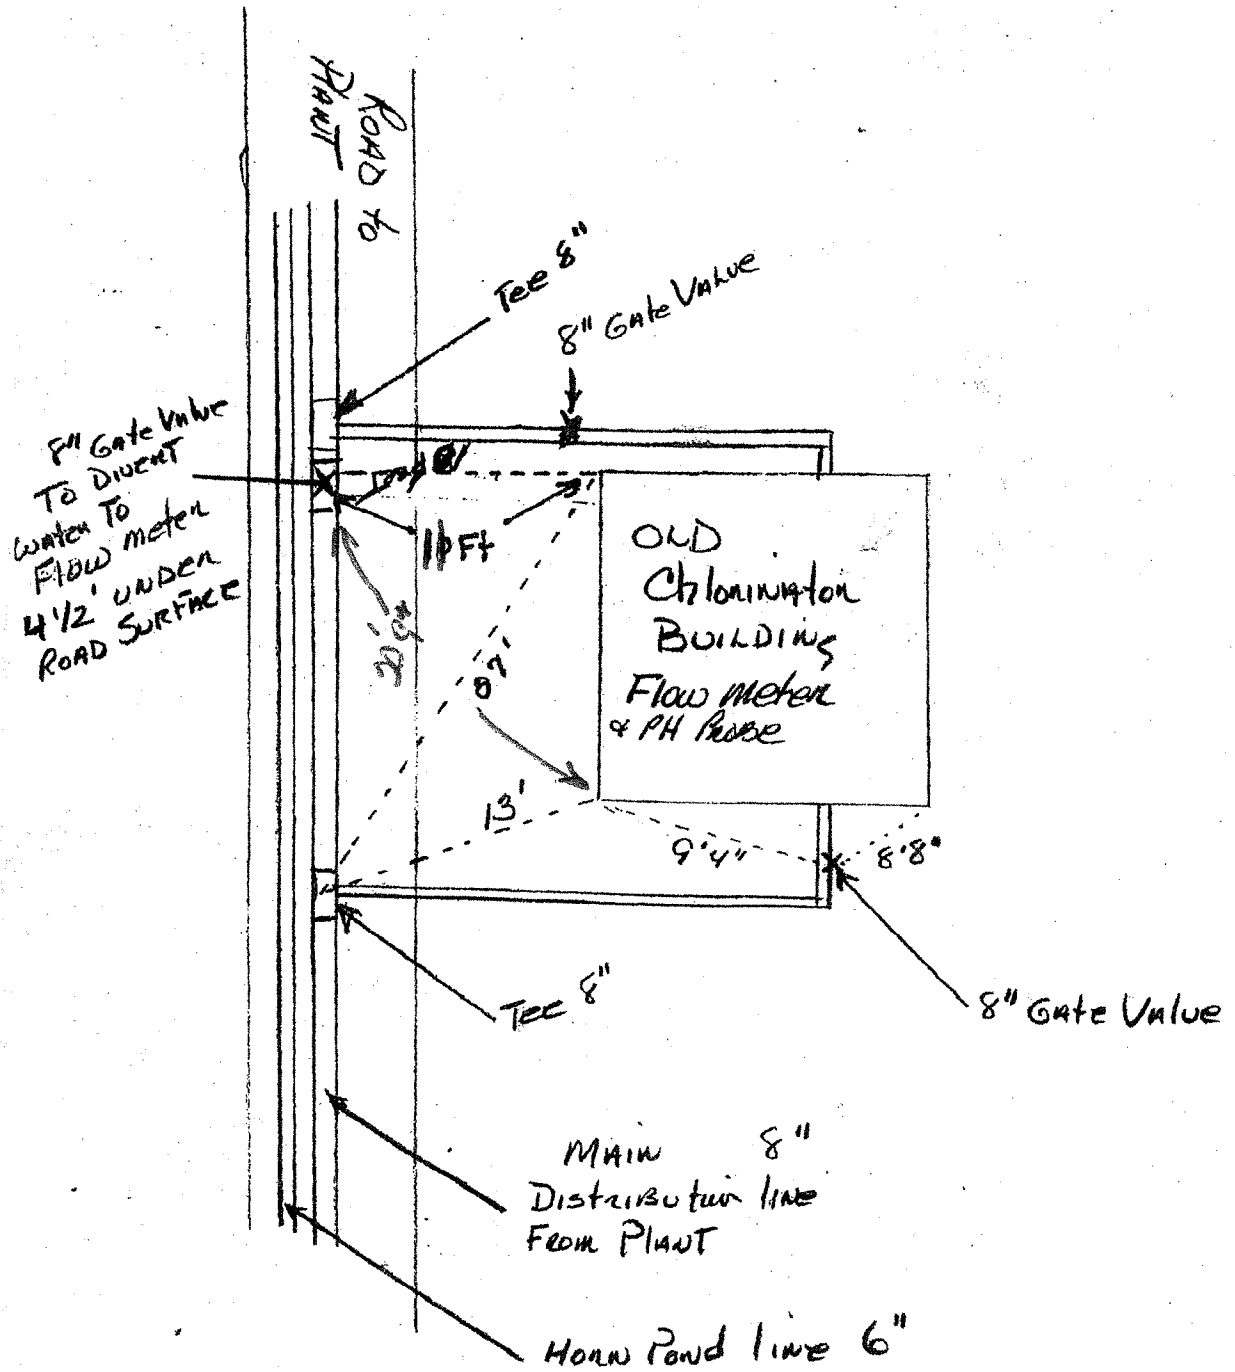
NEW PIPING INSTALLED AT OLD CHLORINATOR ON 11/13/08

PIPING IS FOR RELOCATION OF FINISHED WATER FLOW METER AND PH PROBE TO COMPLY WITH DEP ON LOCATION OF PH PROBE FROM POINT OF INJECTION.
