MEMORANDUM

DATE: June 29, 2023

RE: FY23/FY24 MVP Action Grant – Towns of Chester, Middlefield, and Blandford
Beaver Assessment Technical Memorandum—Town of Chester

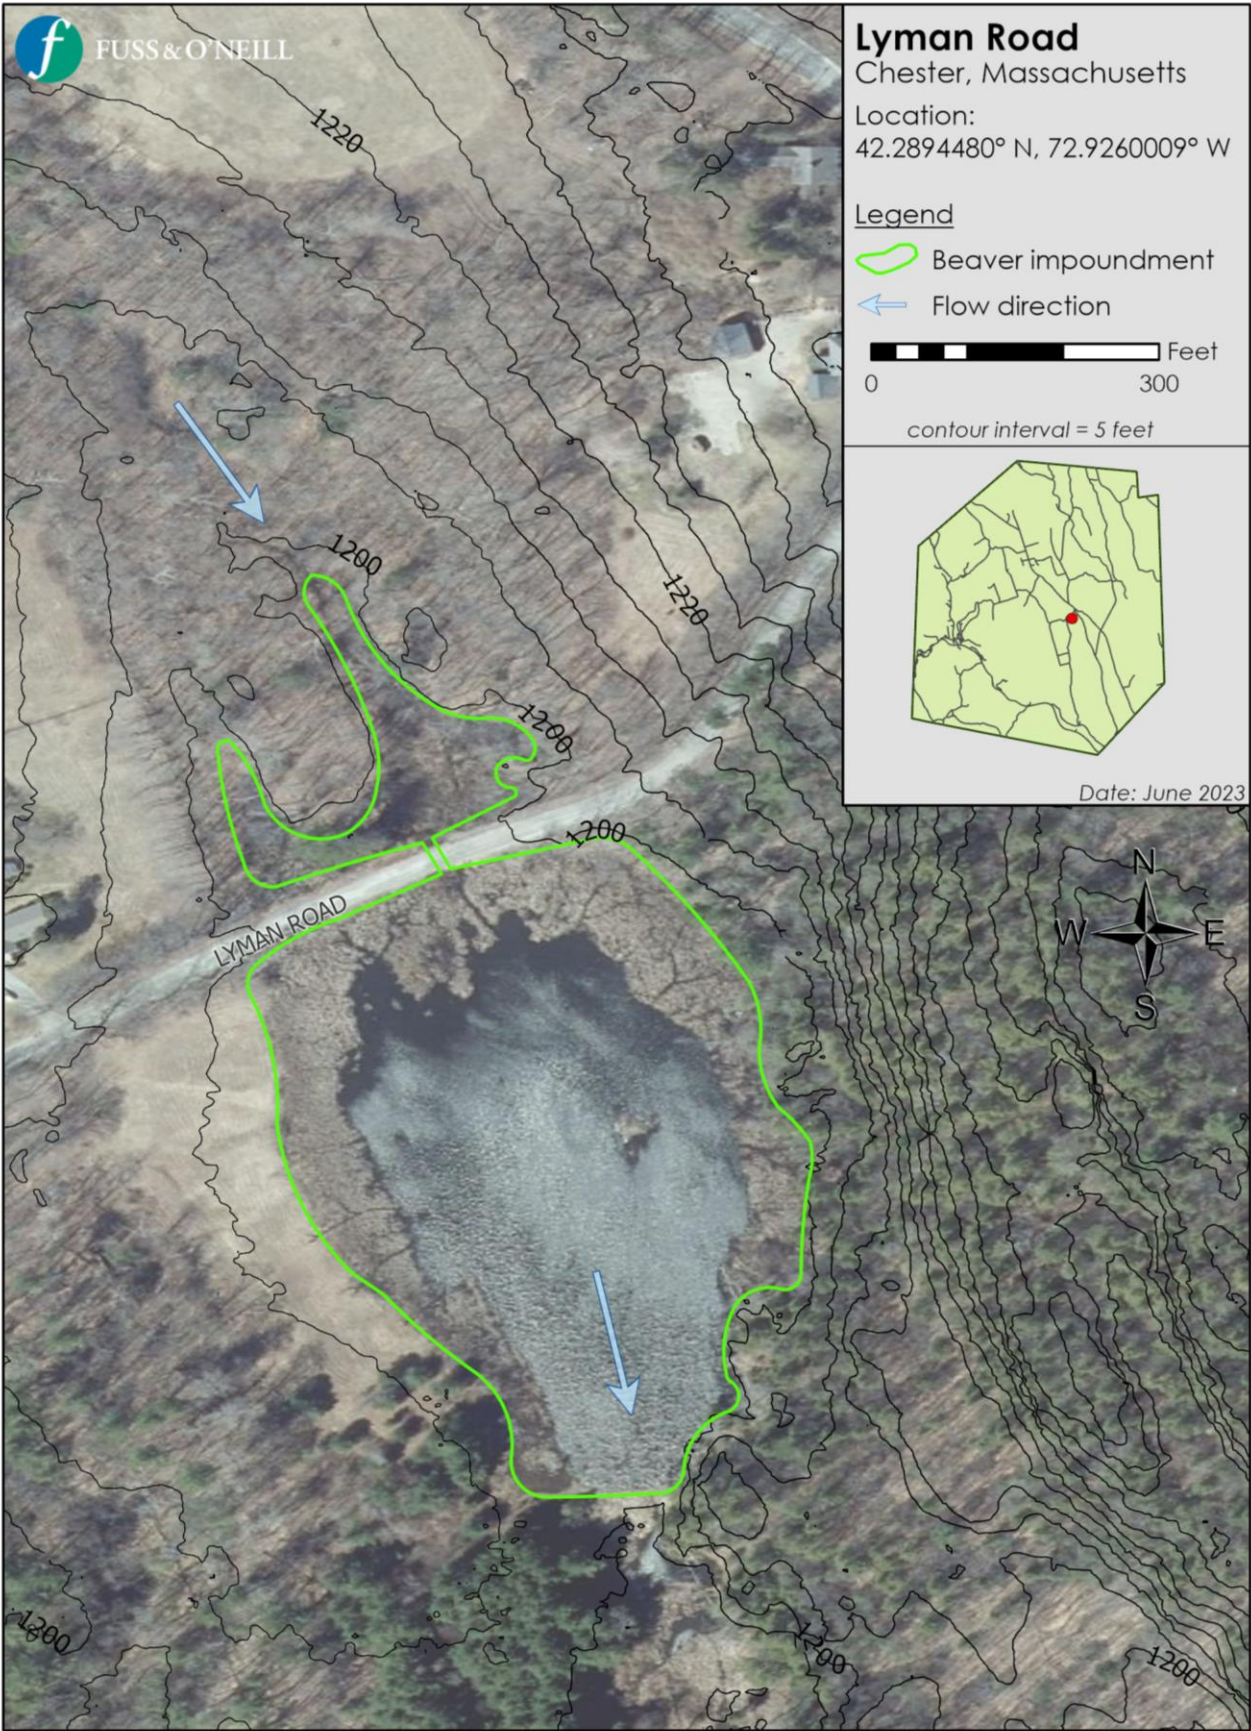
Figure 8. Map of assessed beaver impoundment at Lyman Road.

Current and Potential Impacts (medium): As noted above, the surrounding landscape is primarily undeveloped. Lyman Road itself is the only infrastructure that would be expected to experience impacts from beaver activity at this location and should be the focus of management efforts. One adjacent residence, at 19 Lyman Road, is positioned at a significantly higher elevation above the roadway and impoundment, where it is protected from flooding. Due to the significant area of undeveloped forest and wetlands downstream, downstream impacts to infrastructure or property are not expected; downstream wetlands would provide a buffer in the event of any large release of water due to a breach in one of the beaver dams.

with little to no signs of erosion, and significant change or degradation is not expected. The connected wetland complex, both to the north and south of Lyman Road, appear to offer high value habitat.

- Replace and right-size the existing crossing to convey existing peak flows and those expected as a result of climate change projections for increased storm intensity and peak flows; this will simultaneously help to discourage blockages of the culvert (both active damming by beavers and passive blockages from sediment and debris accumulation).
- Following replacement, continue to maintain and monitor the existing (newly installed) flow-control device and assess beaver response.

- Prevent trapping and other control strategies (e.g., breaching)
- Continue to support the landowner by partnering on management goals, providing funding and assistance where possible for future restoration projects and maintenance of the newly installed flow-leveling device.

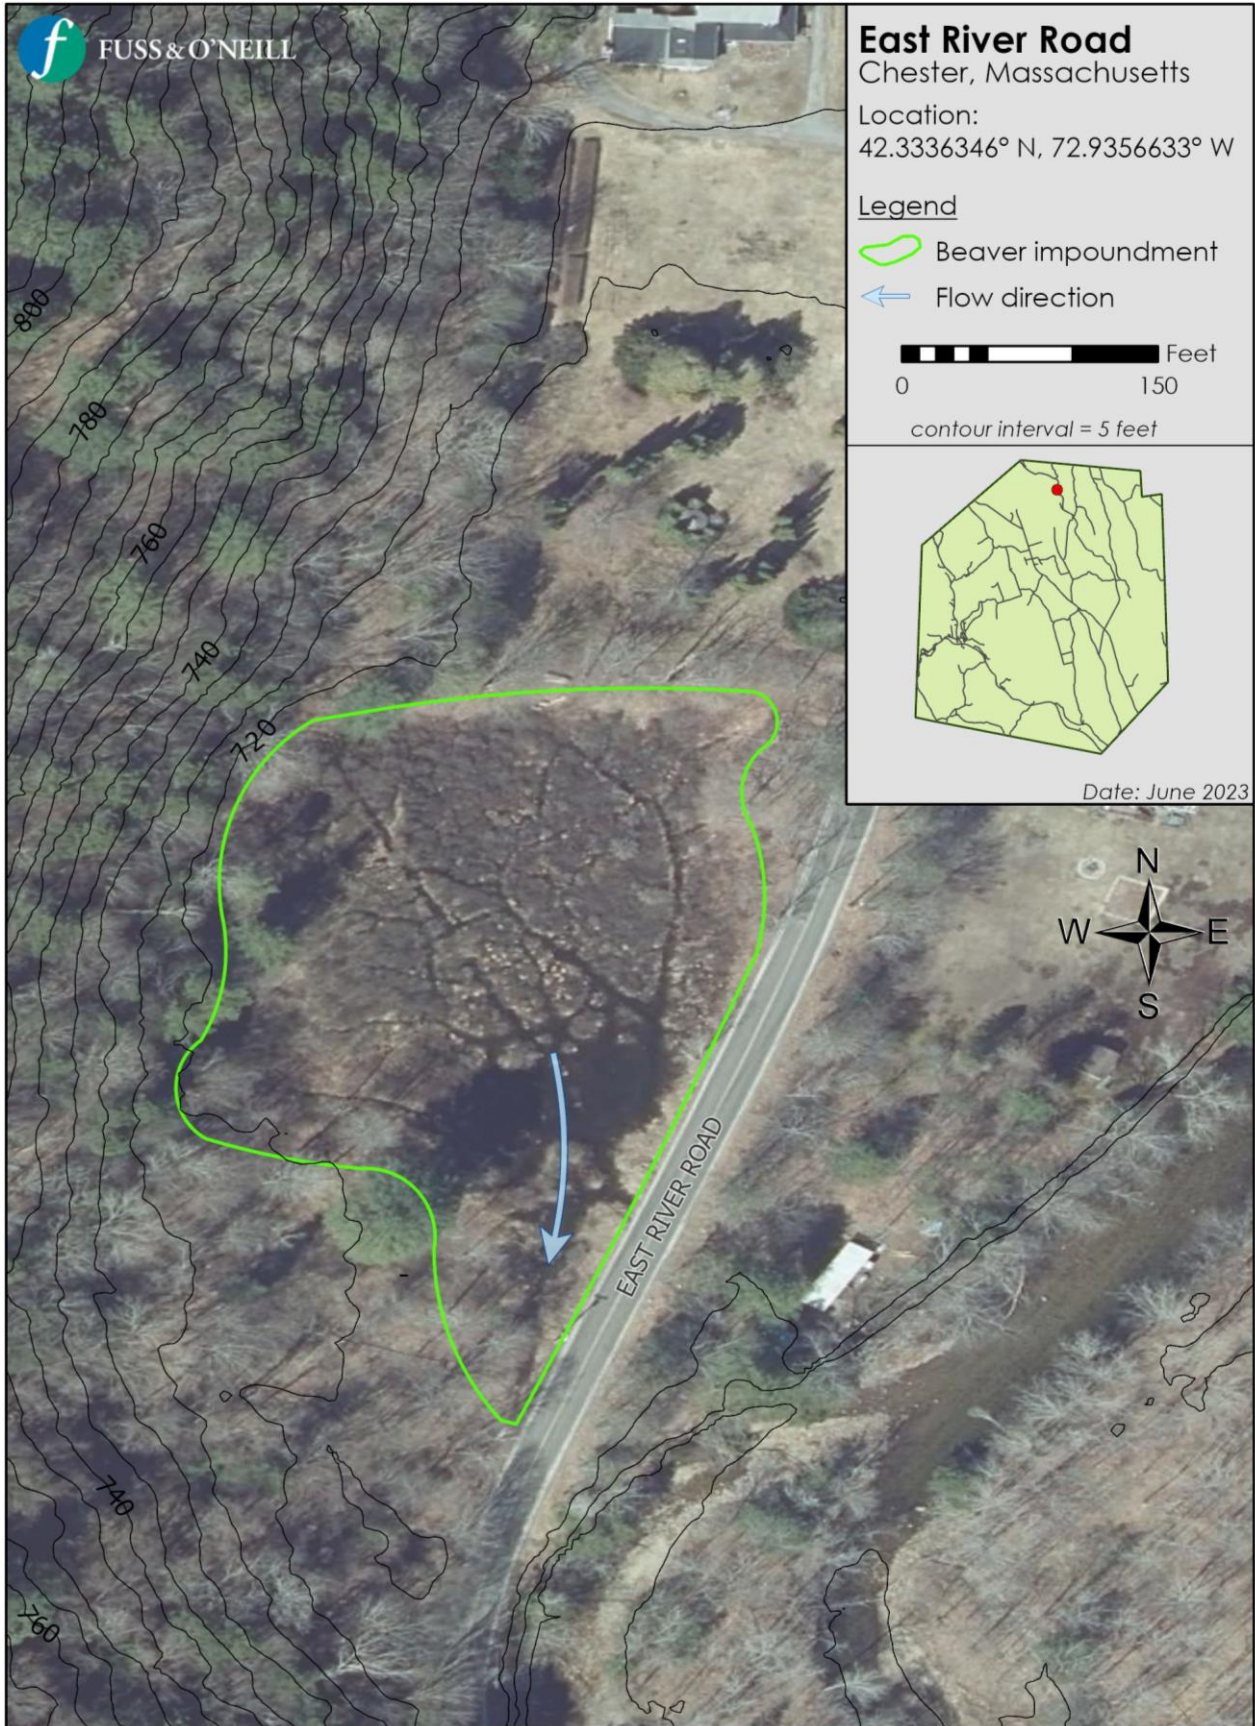
Figure 11. Map of assessed beaver impoundment at East River Road.

Similar to the Lyman Road site, the impoundment at East River Road is very close in horizontal and vertical proximity to the existing roadway. The roadway is paved, and the impoundment level is within one foot or less of the road elevation. There is evidence of an old beaver deceiver but the original culvert under the road is no longer functional (it appears to have collapsed/broken or been purposely filled or blocked). The total impoundment area was estimated to be

As noted above, there does not appear to be a significant threat from flooding at this location, even in the event that high water may overtop the road.

- The original failed culvert and beaver deceiver could be replaced and right-sized to maintain stream flow under the road; however this would likely not be a cost-effective solution given the limited benefits or risk reduction for infrastructure and property.
- Restoration of the excavated overflow/diversion channel is recommended to stabilize the exposed soils and prevent turbidity and sedimentation of the downgradient stream channel and river. Creating a broad, vegetated flow path through this area may help to achieve the same goal of providing an overflow outlet for the impoundment without having detrimental effects to the downstream waterways.
- Better understanding the sources of concern around overtopping may suggest other means of improving the roadway drainage to improve resilience and road safety while coexisting with the beaver impoundment.

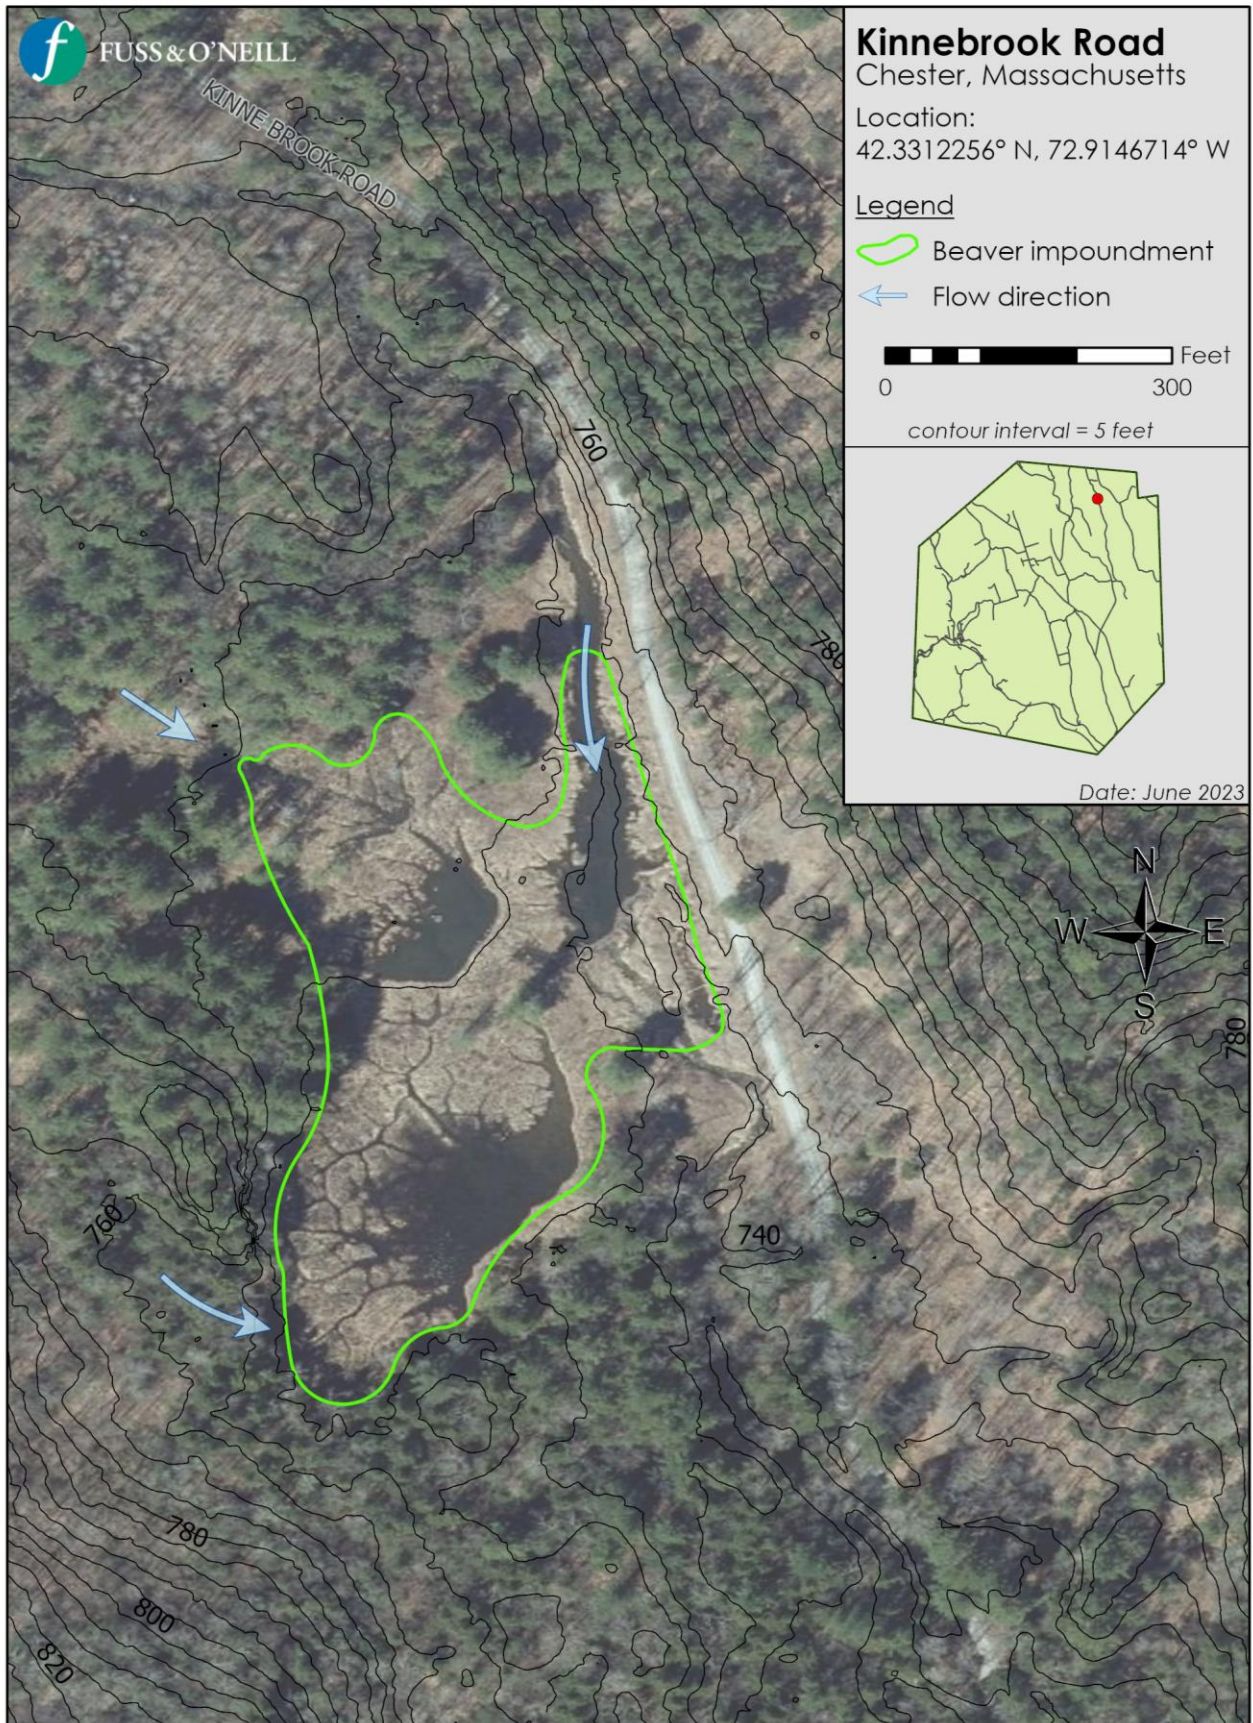
Figure 15. Map of assessed beaver impoundment at Kinnebrook Road.

west, away from the roadway and higher up in the landscape on tributary streams. In May, our field crew passed this site a second time and observed that the primary dam had been breached. It was unclear whether this was a natural occurrence or if the dam had been breached with machinery. The upper dams and impoundments remained intact. When intact, the primary beaver impoundment at Kinnebrook Road was estimated to be 3.6 acres, with an approximately 2.57 square mile total contributing drainage area.

Kinnebrook Road was experiencing some minor drainage problems and ponding during our site visits; these were attributed to rutting from logging vehicles and the recent increase in runoff caused by the clearcutting of the adjacent upgradient slope.

This is a large beaver wetland complex with little to no downstream impact risks and high value habitat and flood storage capacity. Impacts to the roadway are unlikely and, based on our field observations, no immediate action is necessary to protect the road from damage or overtopping due to beaver activity (although erosion and drainage problems may occur due to the recent forest cutting immediately east and upgradient of the road). There are no culverts or other infrastructure at this location. The site should be managed as a beaver restoration site, where beaver activity is recognized as broadly beneficial for maintenance and restoration of wetland habitats, storm dampening, water filtration, and other ecosystem services. Further, given the surrounding landscape and topography, expansion or relocation of beavers to undesirable locations is not a concern. In order to maintain the additional habitat and flood resilience benefits provided by beavers, conditions for continued beaver activity should be encouraged or at least maintained in order to:

- Prevent trapping and other control strategies (e.g., breaching of dams)
- Support beaver populations at the site (i.e., plantings, BDAs), to enhance resiliency and encourage sustained beaver activity at the site.

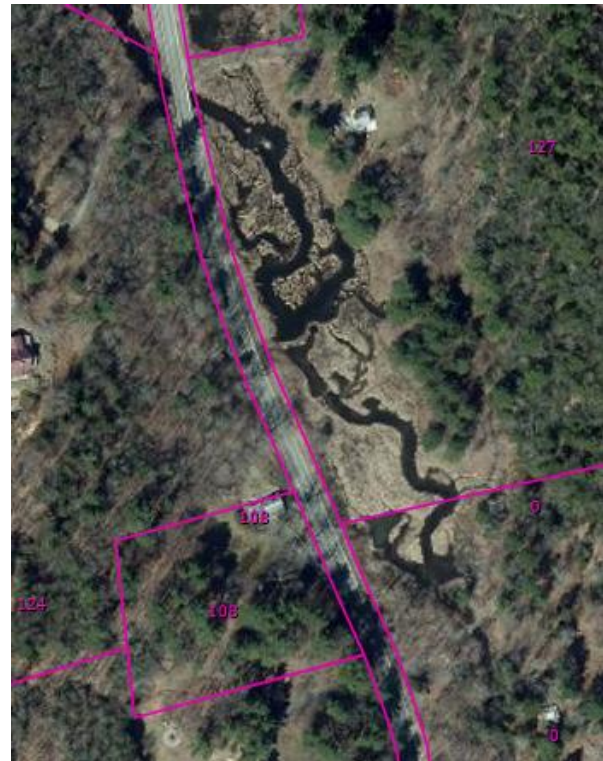
Members of the Town project committee also identified a location on Skyline Trail as an area of former beaver activity which previously resulted in flooding impacts to one or more driveways. This location is located along Roaring Brook, where it crosses from west to east under a paved stretch of Skyline Trail via a small bridge. Aerial imagery clearly shows a series of former beaver impoundments across an approximately 1,000-foot long by 200-foot wide area contained within the road right-of-way and property of 127 Skyline Trail. Remnants of the breached beaver dams remain across the floodplain, which is now devoid of trees. Remnants of the former dams at this site indicate deep impoundments, with at least one dam standing at shoulder-height. Small shrubs are starting to grow in, following a typical early successional pattern; however, down cutting is evident throughout the site as the channel reforms through the former impoundment. A deeply incised channel now means that the brook will be disconnected from and unable to access its floodplain during most storm events. This will in turn limit or nullify the ability of the floodplain to slow or absorb flood waters. Given the proximity of the channel to the roadway at some meanders, the road may potentially be threatened by continued erosion and higher velocities in the absence of the impoundments which would formerly have resulted in significantly decreased flow velocities through this reach of Roaring Brook. We also noted that a dry hydrant which

Figure 17. 2021 Aerial imagery from MassMapper captures the series of former beaver impoundments on the west side of Skyline Trail.

used to reach into the beaver impoundment is no longer viable as its position is approximately 18-24” above the water level of the free-flowing brook.
