# Chester Water Asset Management Plan

Town of Chester, MA

August 2025

**Tighe&Bond**

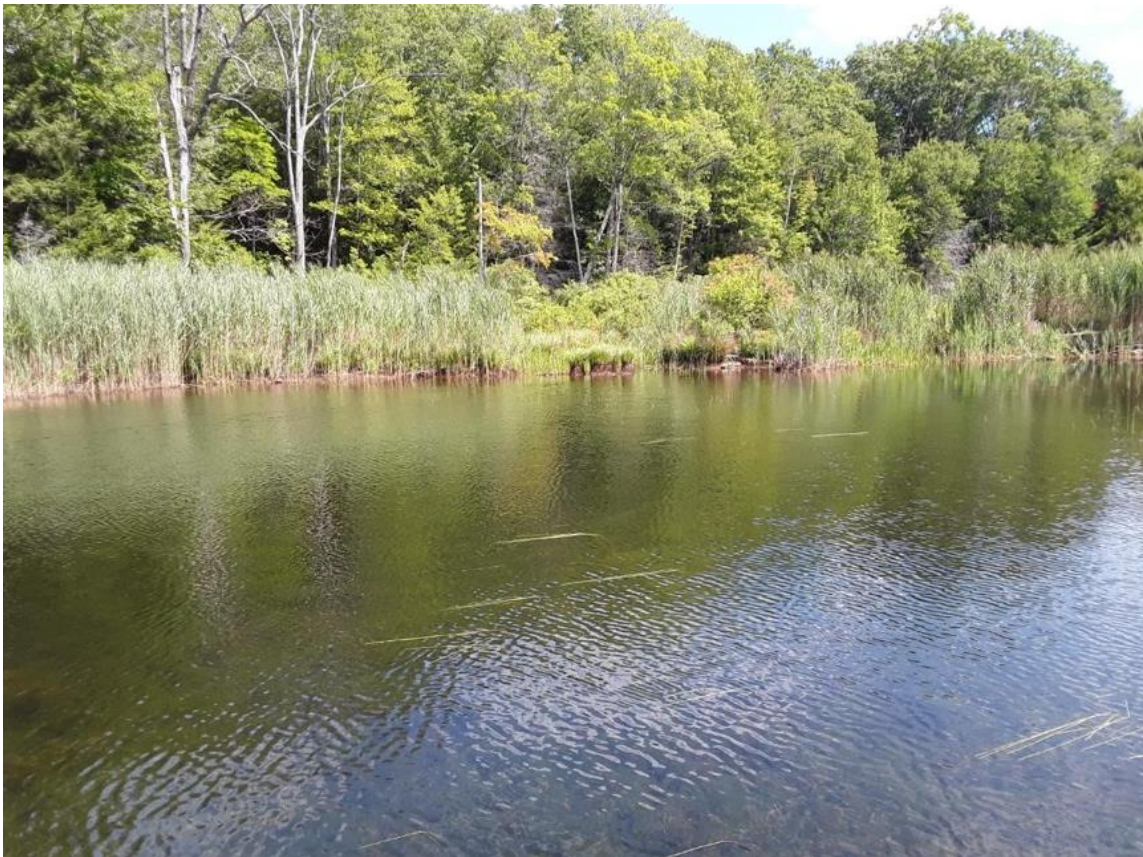
**FIGURE 2-5**

The Horn Pond reservoir is located in Becket, MA, off Wade Inn Road roughly 1 mile from the treatment plant and 2 miles from the center of Chester. The reservoir has a drainage area of 0.6 square miles and a safe yield of 170,000 gallons per day. The reservoir is equipped with an intake pipe running along the bottom of the pond, isolation valves, and an underground vault with screens. Horn Pond connects to the Austin Brook water treatment plant through a 6-inch ductile iron pipe laid cross county. The intake for this reservoir was inspected and improved in 2016 and is therefore considered to be in good condition. Access to Horn Pond is currently a major concern as the access road has been washed away for several years and needs reconstruction. Currently, water department staff needing to access Horn Pond must utilize private property.

Horn Pond Reservoir

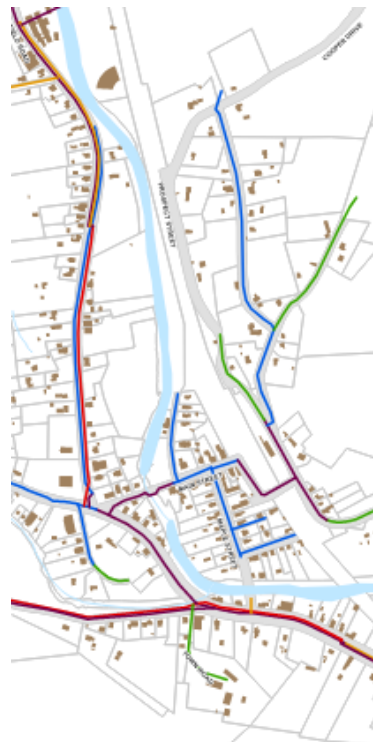
The following sections of line were identified as areas that are in need of leak detection: Huntington Rd, Main St, Maple St, and Middlefield Rd. These sections of lines were identified as immediate-risk or high-risk sections of line based on the asbestos cement pipe being installed in high acidic soil and the age of the lines. The lines in these areas range from 1 to 8 inches in diameter and were installed in the 1990s or the installation date is unknown. It is recommended that these sections of lines be inspected for leak detection.

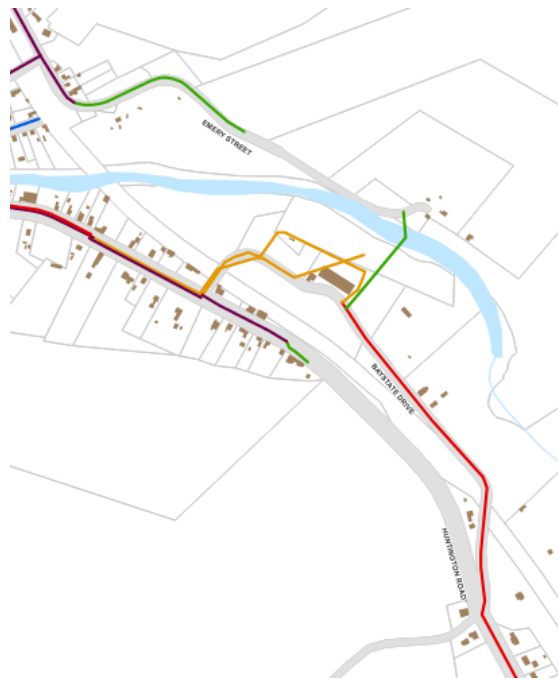
The following sections of line were identified as areas that are in need of leak detection: Baystate Dr, from Baystate Dr to Emery St, and the eastern section of Huntington Rd. These sections of lines were identified as immediate-risk or high-risk sections of line based on the asbestos cement pipe being installed in high acidic soil and the age of the lines. The lines in these areas range from 2 to 8 inches in diameter and no installation dates are known. It is recommended that these sections of lines be inspected for leak detection.

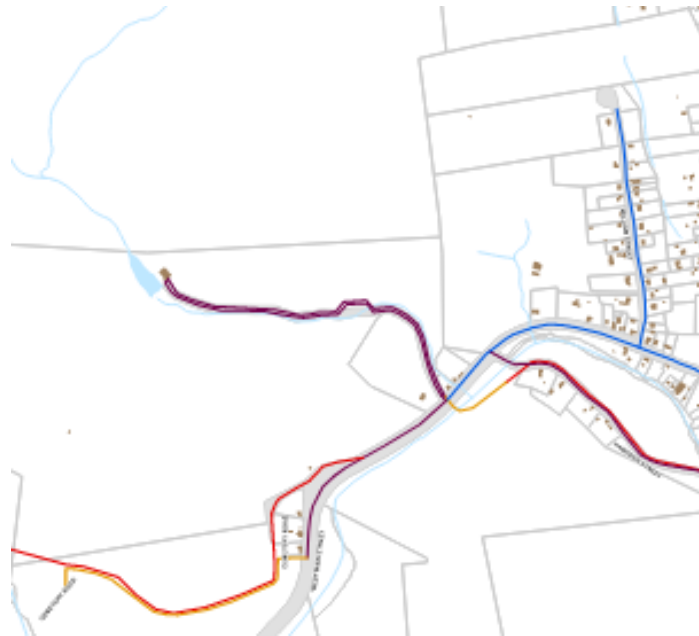
The following sections of line were identified as areas that are in need of leak detection: Reservoir Drive and the end of Horn Pond Line. These sections of lines were identified as high-risk sections of line based on the age of the lines. The lines in these areas range from 6 to 8 inches in diameter and were installed in the 1990s. It is recommended that these sections of lines be inspected for leak detection.
